Miscellaneous Paper CERC-96-3
May 1996

Physical Model Study of Breakwater Stability, Kodiak, Alaska

Prepared for U.S. Army Engineer District, Alaska

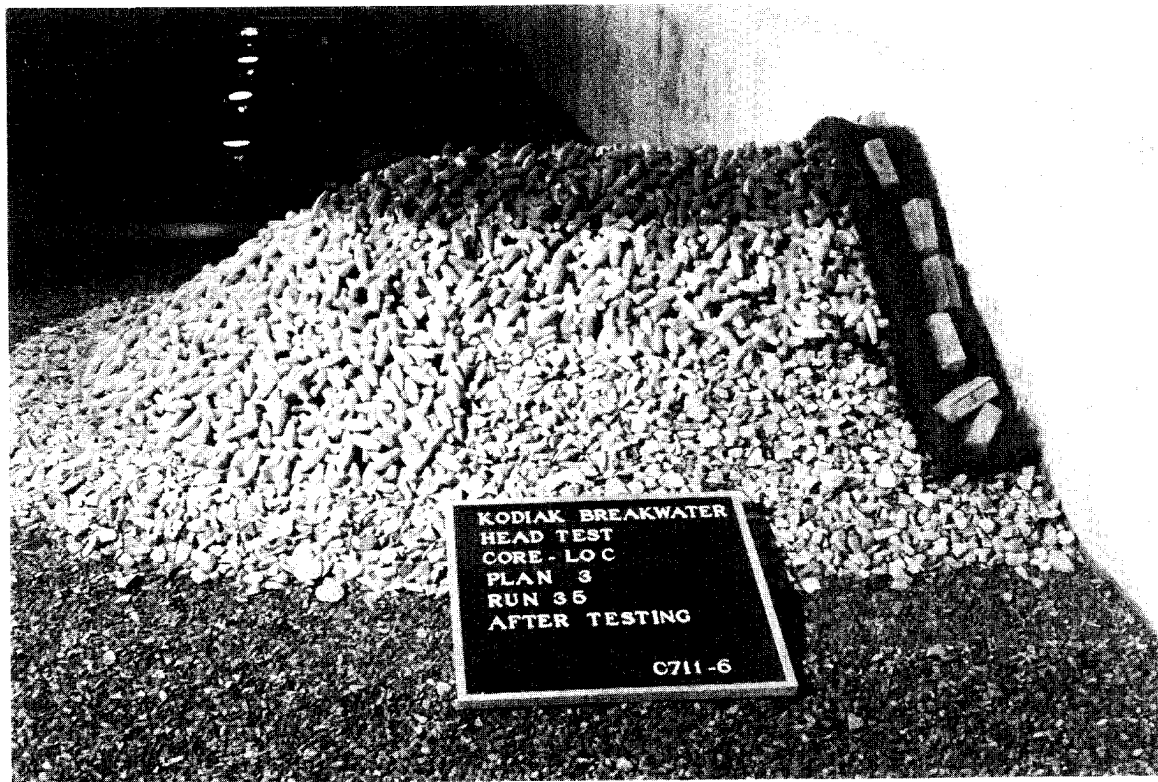
Photo 14. Harbor-side view of model breakwater Plan 3 after testing

Three runs of 48 min each were conducted at $T_p = 14.0$ sec and $H_{m0} = 2.1$ m (7.0 ft). During the third run, the structure failed when heavy overtopping pushed Core-Loc units down the harbor side of the trunk with enough force to push the B-stone on down the slope in front of the Core-Locs. There was no evidence of undermining. The 14-sec waves overtopped the structure trunk as a surging breaker, causing a very heavy downrush on the harbor side. Because the B-stones were placed by dumping, they were not interlocked into a matrix as is the case with individually placed and seated armor units. The B-stone therefore had little resistance to sliding. Hydrodynamic forces on the Core-Locs were sufficient to push the B-stone downslope and cause a slumping failure in the Core-Locs.

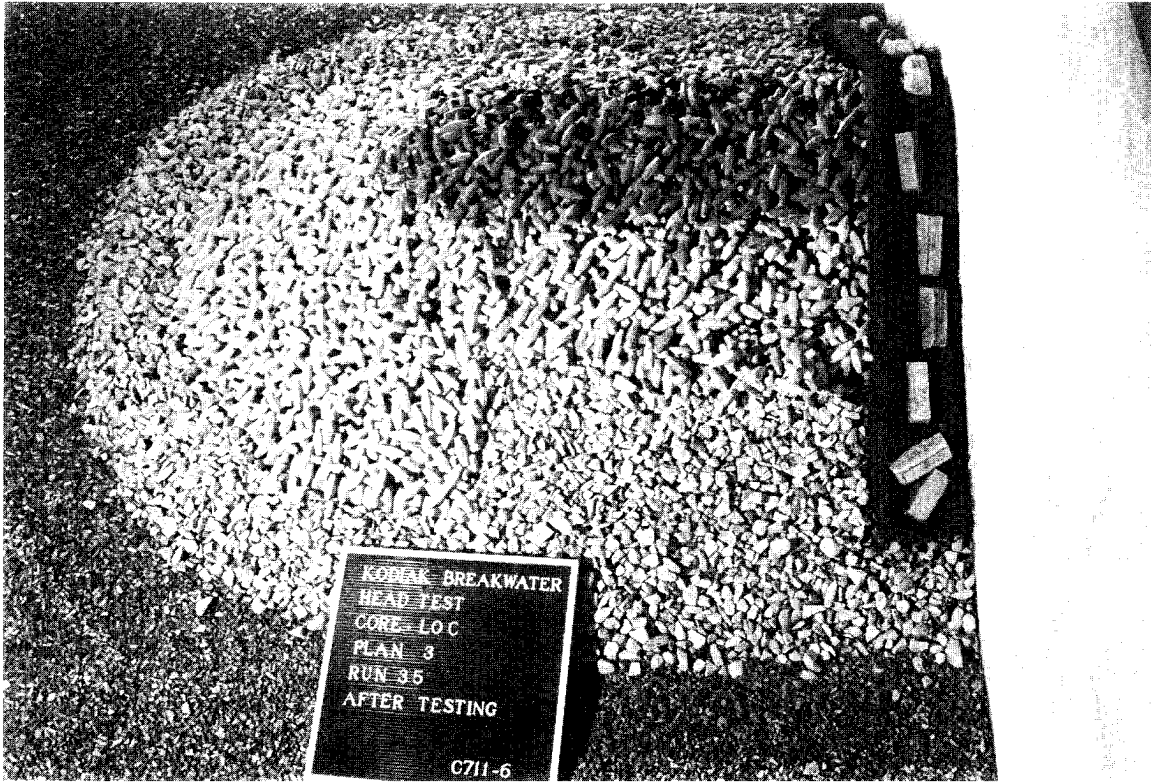
Photo 15. Damage sustained by model breakwater during testing of Plan 3

Until the failure occurred, the only movement observed was one Core-Loc displaced from the harbor-side head. The displaced unit was the same unit displaced in Plan 2. During the rebuild of the crest for Plan 3, the Core-Loc displaced from the harbor-side head was replaced into its original location in the matrix, but apparently was not adequately anchored. Photos 13 and 14 show sea-side and harbor-side views, respectively, of Plan 3 after testing. Photo 15 is another harbor-side view of Plan 3 after testing taken at a higher angle to better display the damage.

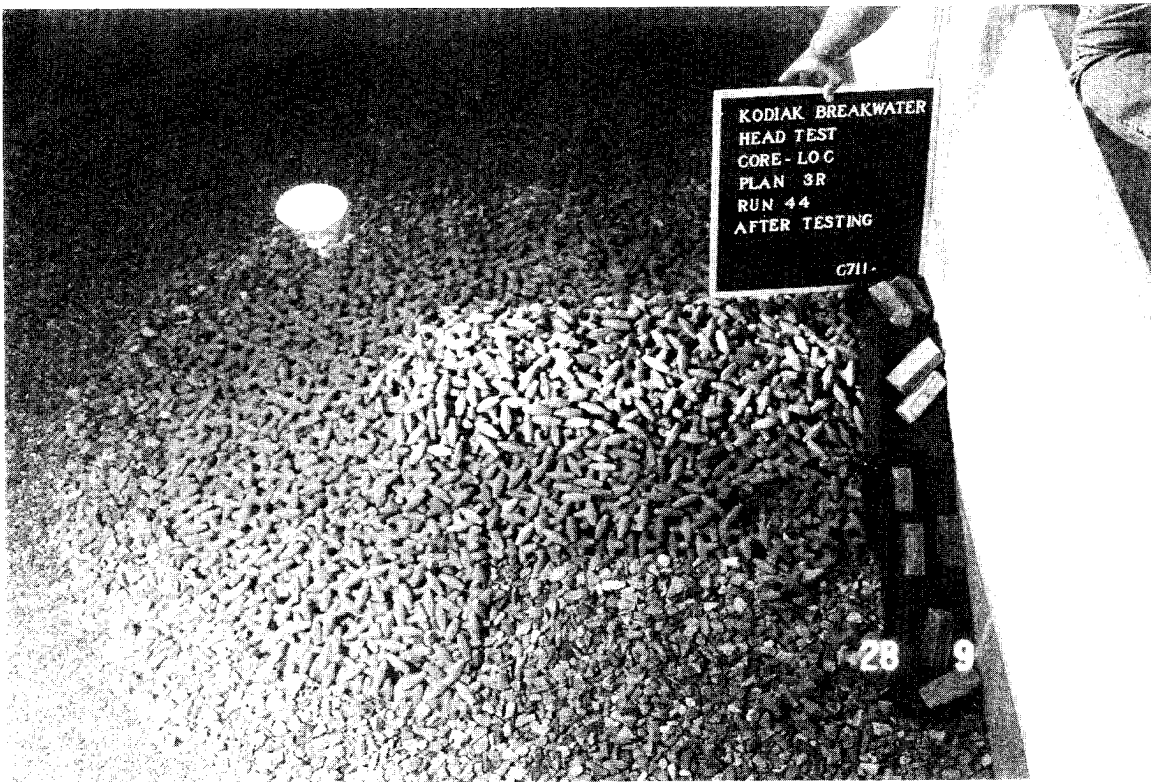
Photo 16. Damage sustained by model breakwater during demonstration runs of Plan 3R

At swl = +3.2 m (+10.5 ft) mllw, a short demonstration run was conducted at $T_p = 14$ sec and $H_{m0} = 1.7$ m (5.5 ft) with no noticeable movement on the structure, but the structure failed during a test at $T_p = 14$ sec and $H_{m0} = 2.1$ m (7.0 ft). Heavy overtopping caused armor units on the harbor-side trunk above swl to slough, exposing the underlayer.

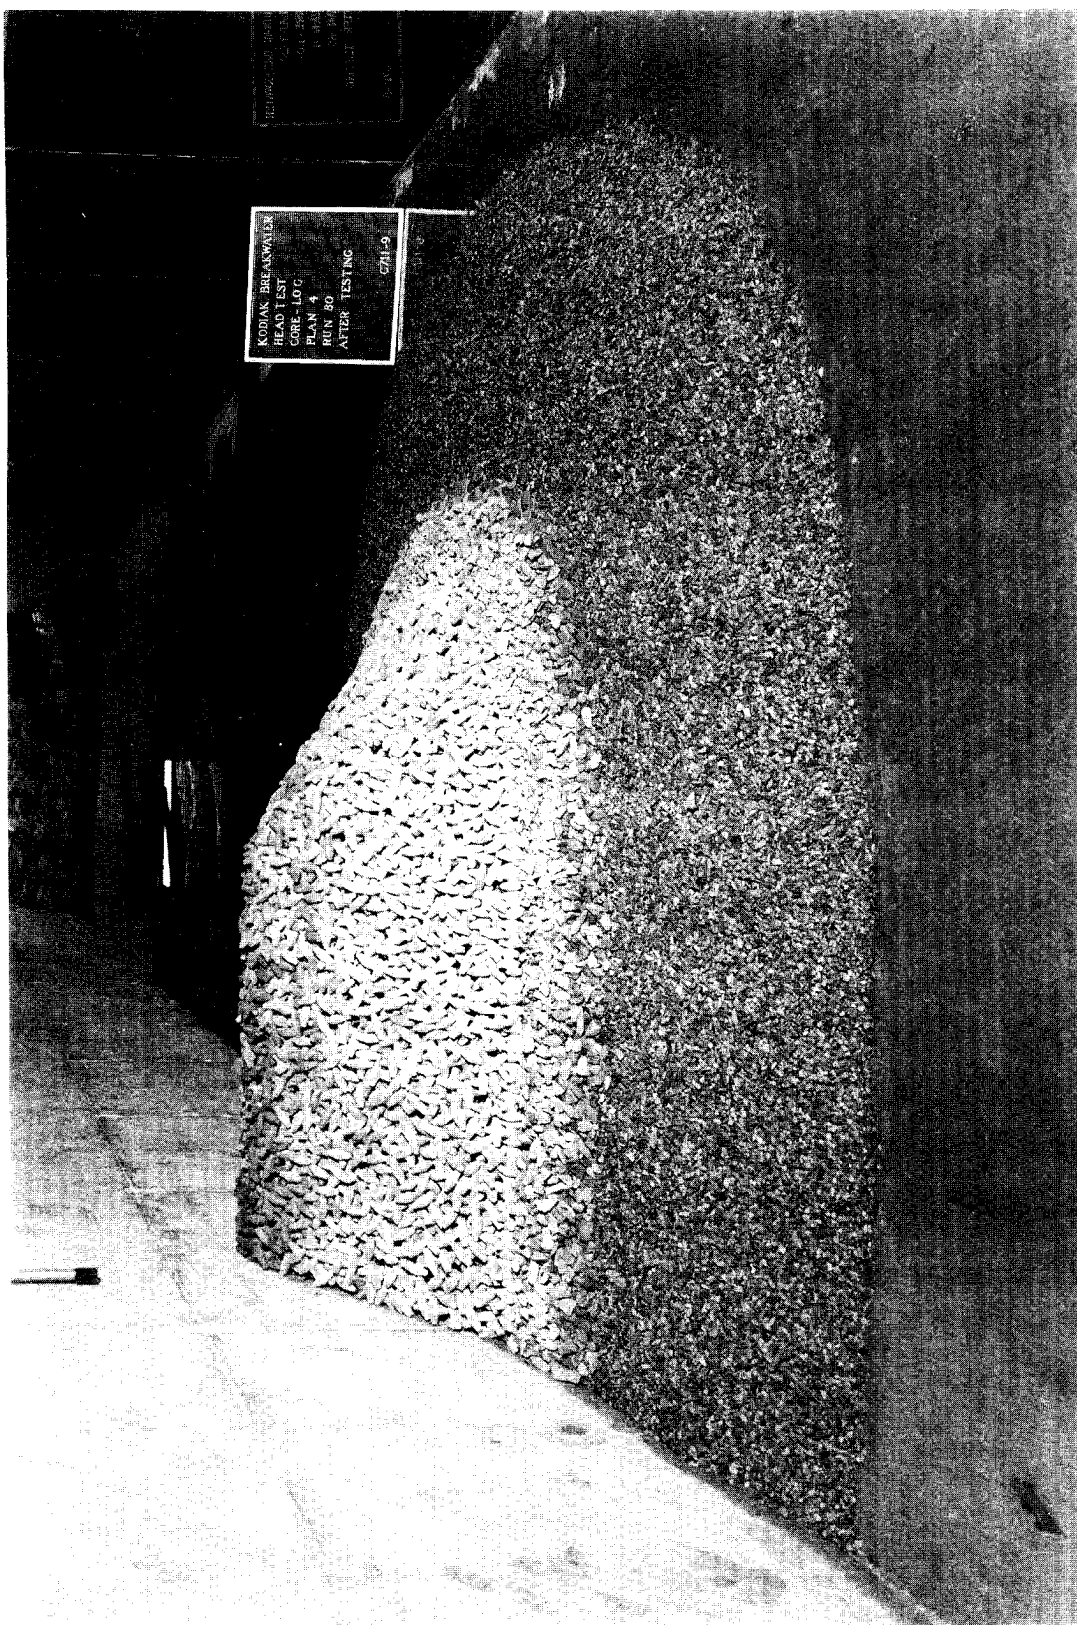
Photo 17. Sea-side view of model breakwater Plan 4 after testing

Photos 17, 18, and 19 show sea-side, end, and harbor-side views, respectively, of Plan 4 after testing.

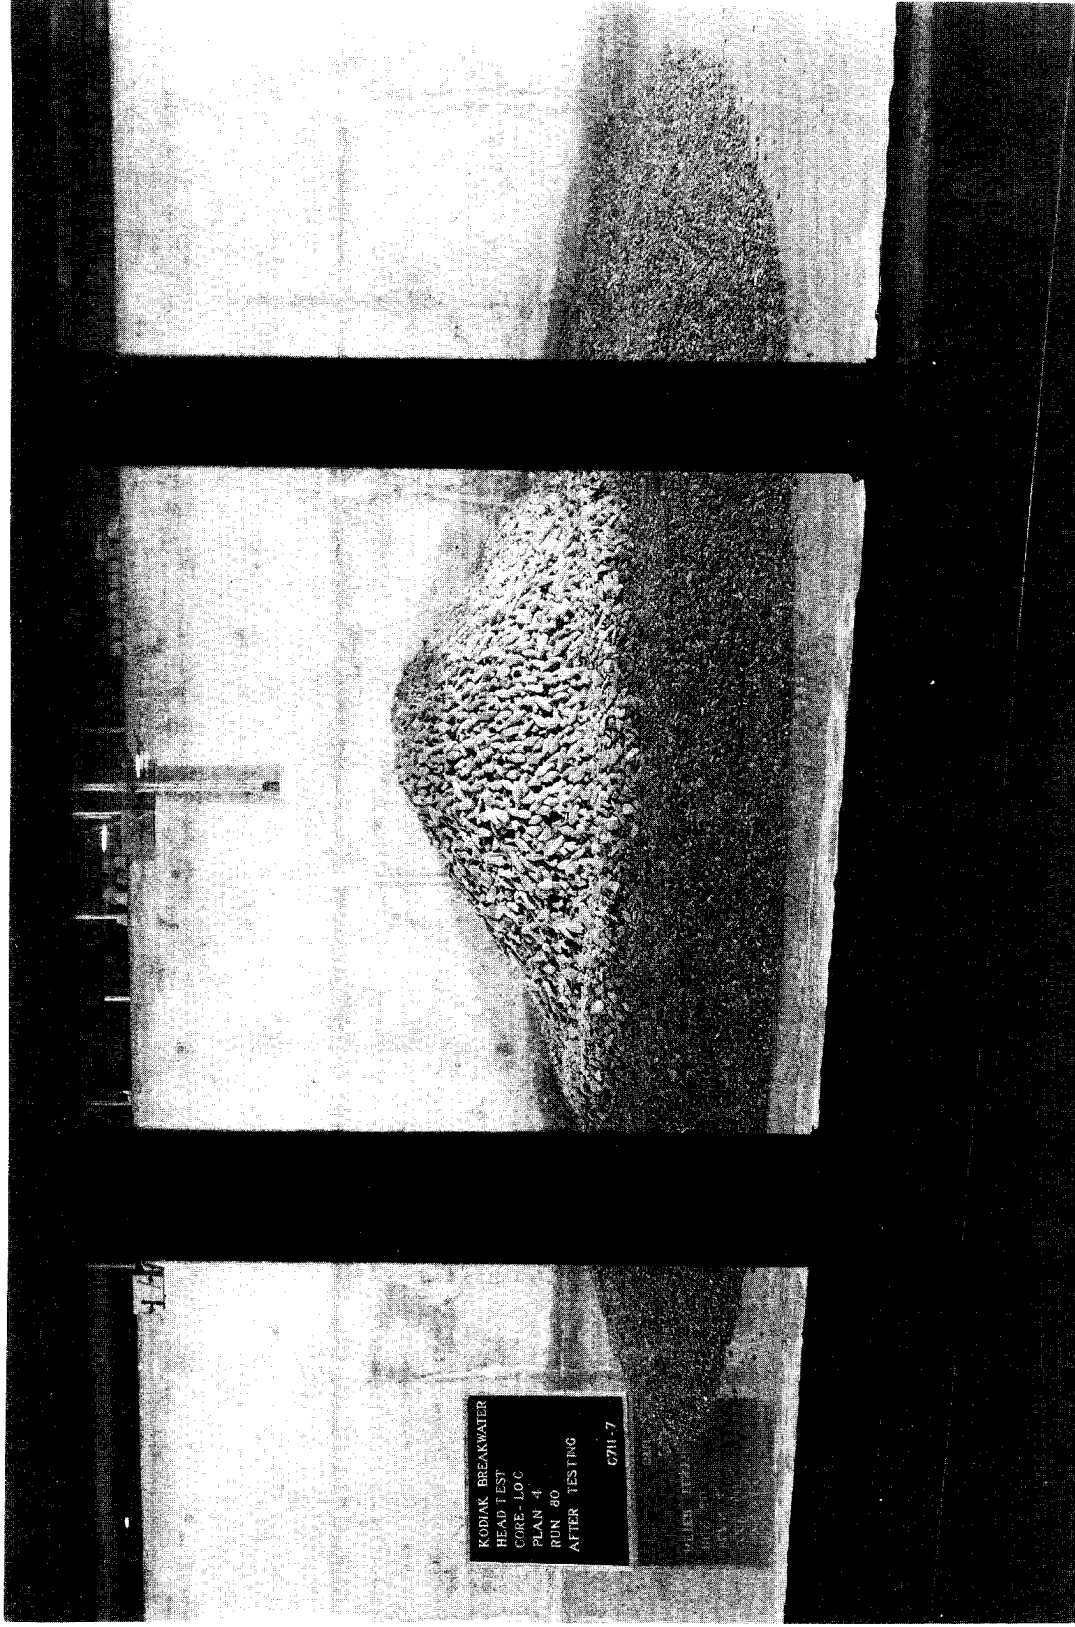
Photo 18. End view of model breakwater Plan 4 after testing

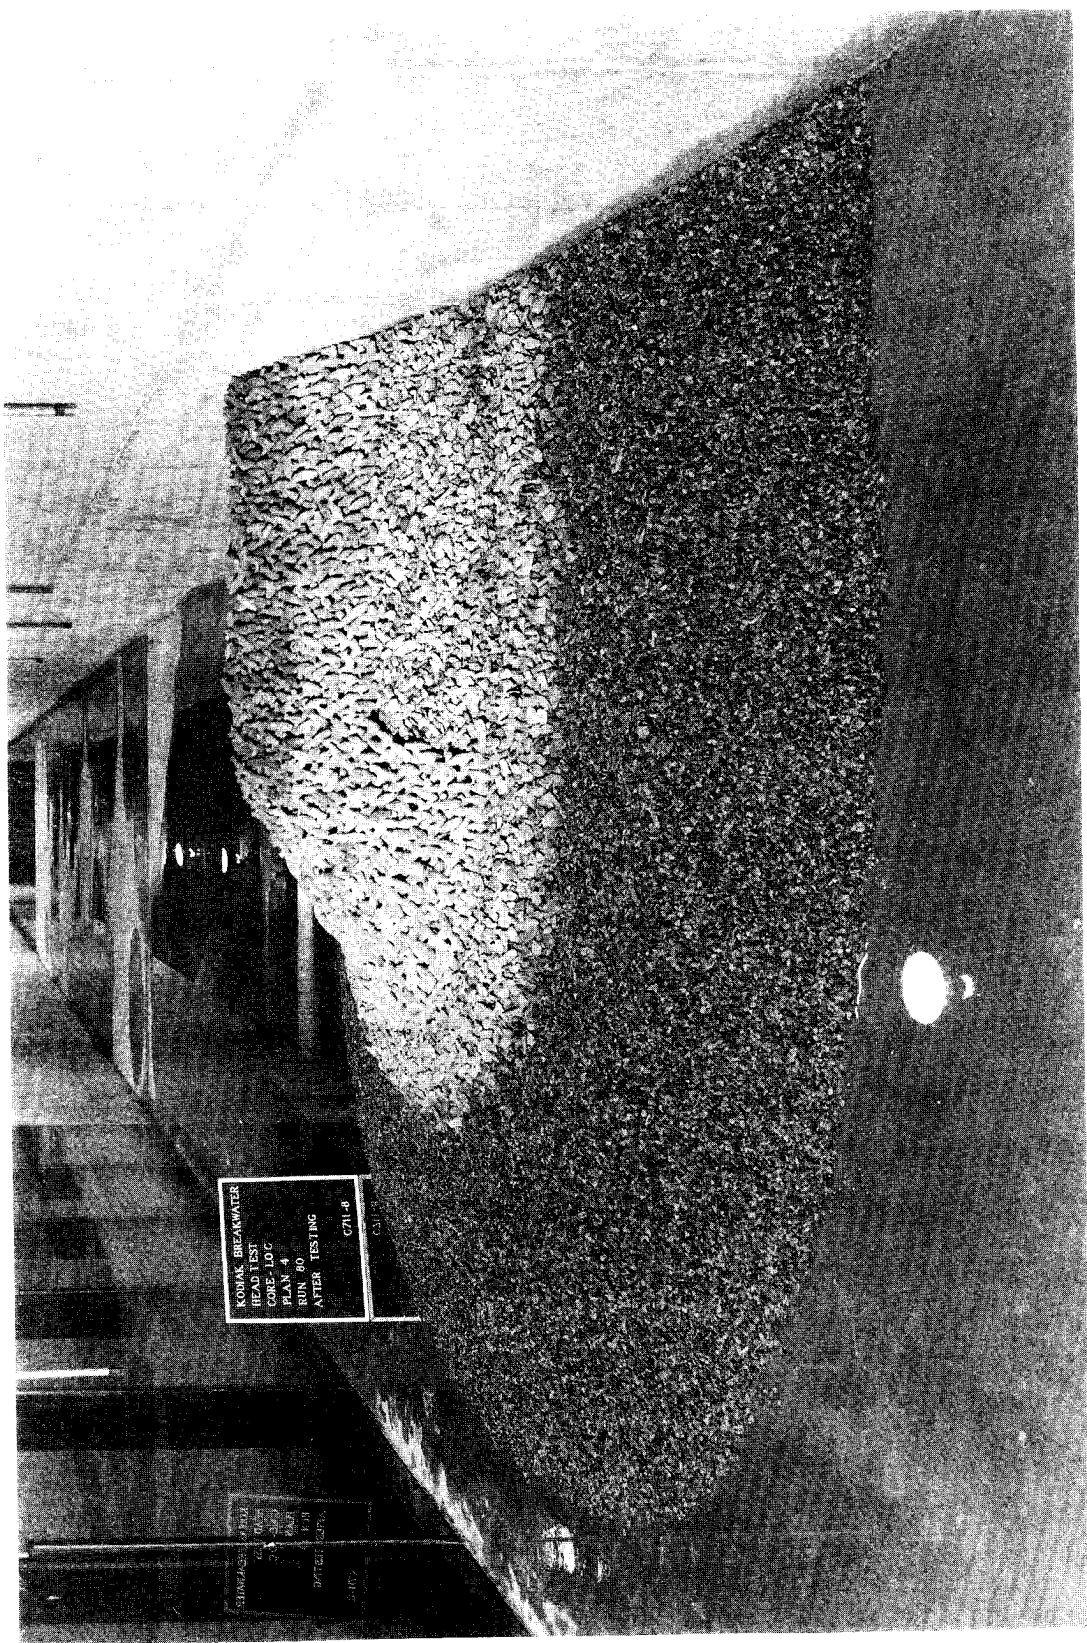
Photo 19. Harbor-side view of model breakwater Plan 4 after testing

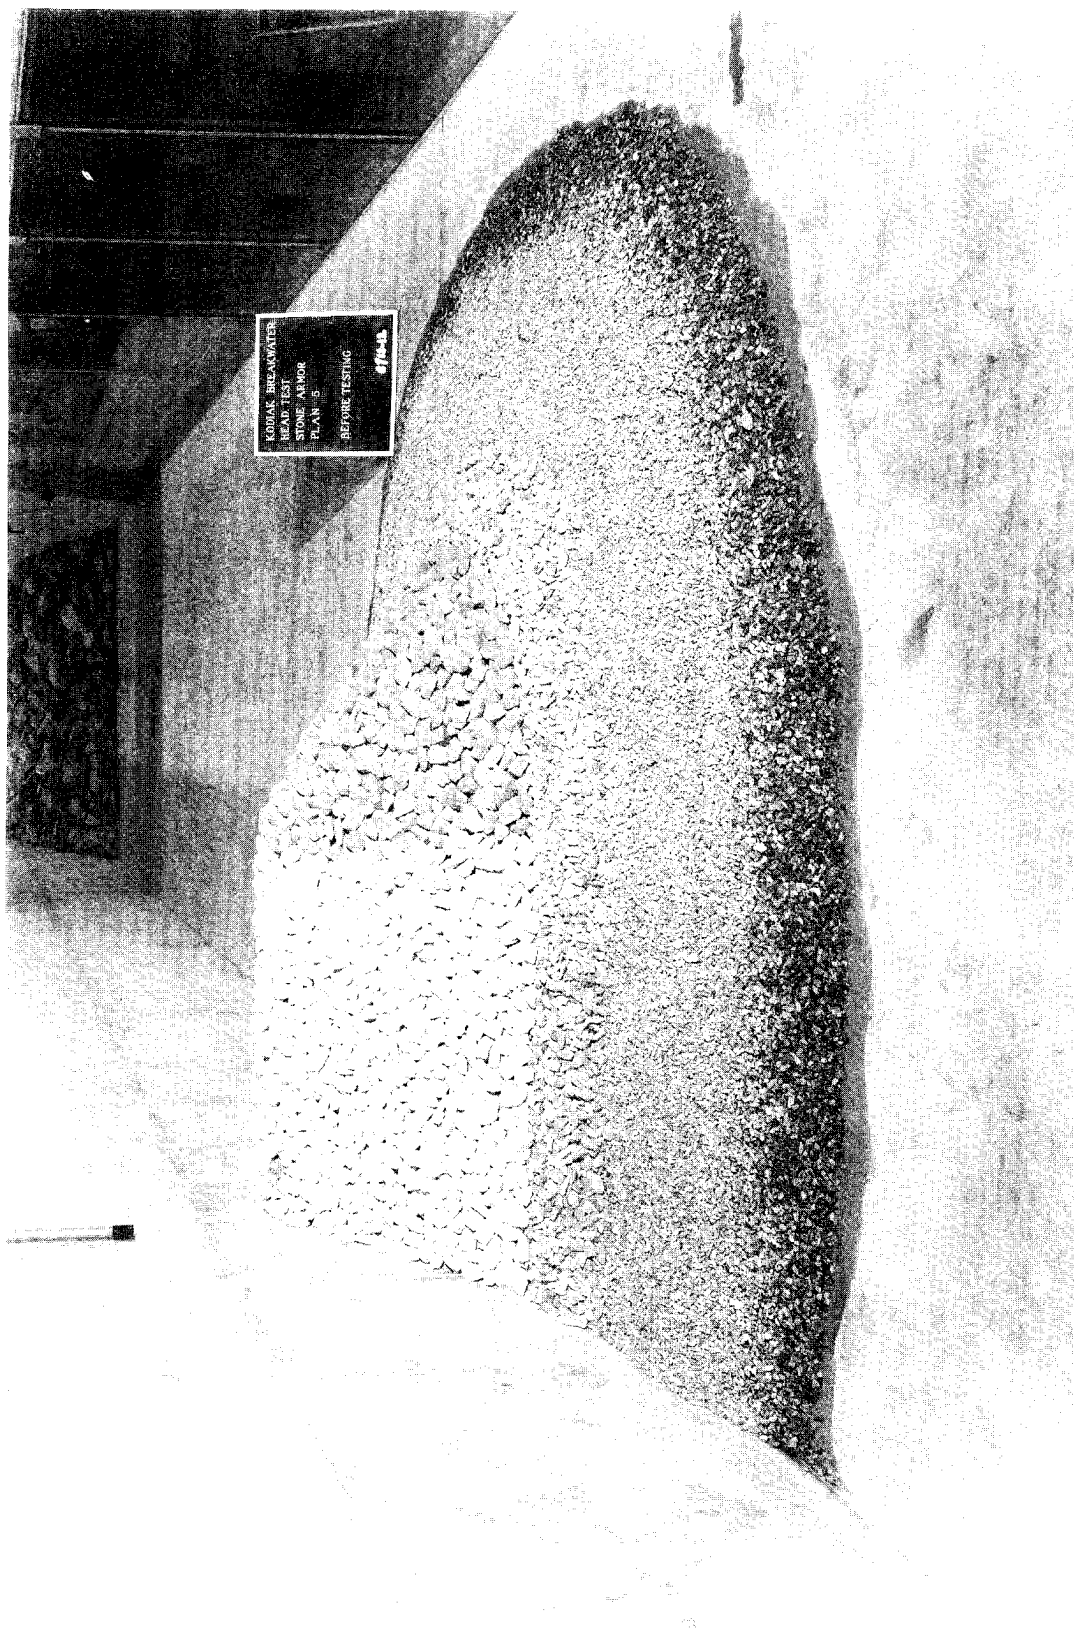
Photo 20. Sea-side view of model breakwater Plan 5 before testing

Plan 5 used armor stone instead of Core-Locs for primary armoring of the structure. All Core-Locs were removed from the structure and the underlayer was smoothed and reshaped as necessary. A double layer of armor stone with $W_{s0} = 1,450$ kg (3,200 lb) was placed over the B-stone underlayer. Crest elevations of the structure core and underlayer were the same as in Plans 1, 2, 3, and 4, but the double layer of armor stones raised the final crest elevation higher than the single layer of Core-Locs used on earlier test configurations. Stones were placed in a manner similar to dropping each stone individually from a backhoe, and no attempt was made to specially place or key the stones. Stones used on the model were more uniform in size than would be expected on the prototype, with model stones typically within ± 10 percent of W_{s0} . Figure 8 shows a cross section of the Plan 5 trunk; Figure 9 shows a cross section of the Plan 5 head. The vertical panels of rubberized matting used in Plan 4 were used again in Plan 5. Photos 20, 21, and 22 show sea-side, end, and harbor-side views, respectively, of Plan 5 before testing.

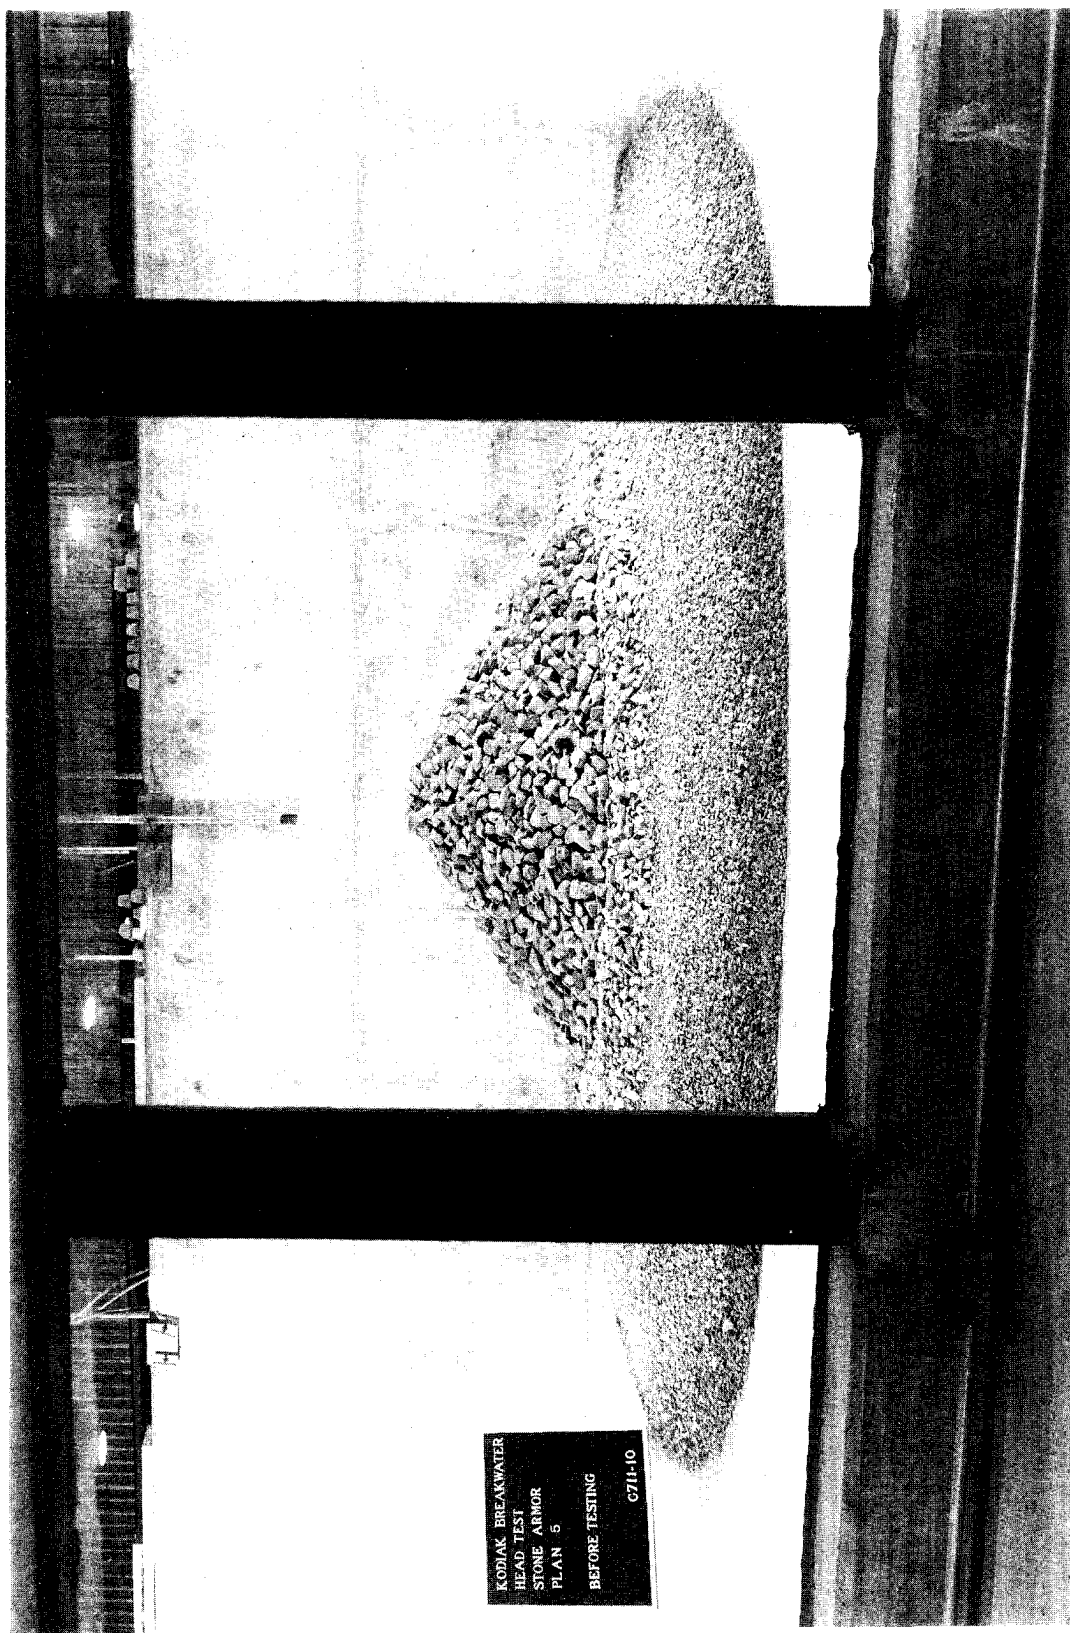
Photo 21. End view of model breakwater Plan 5 before testing

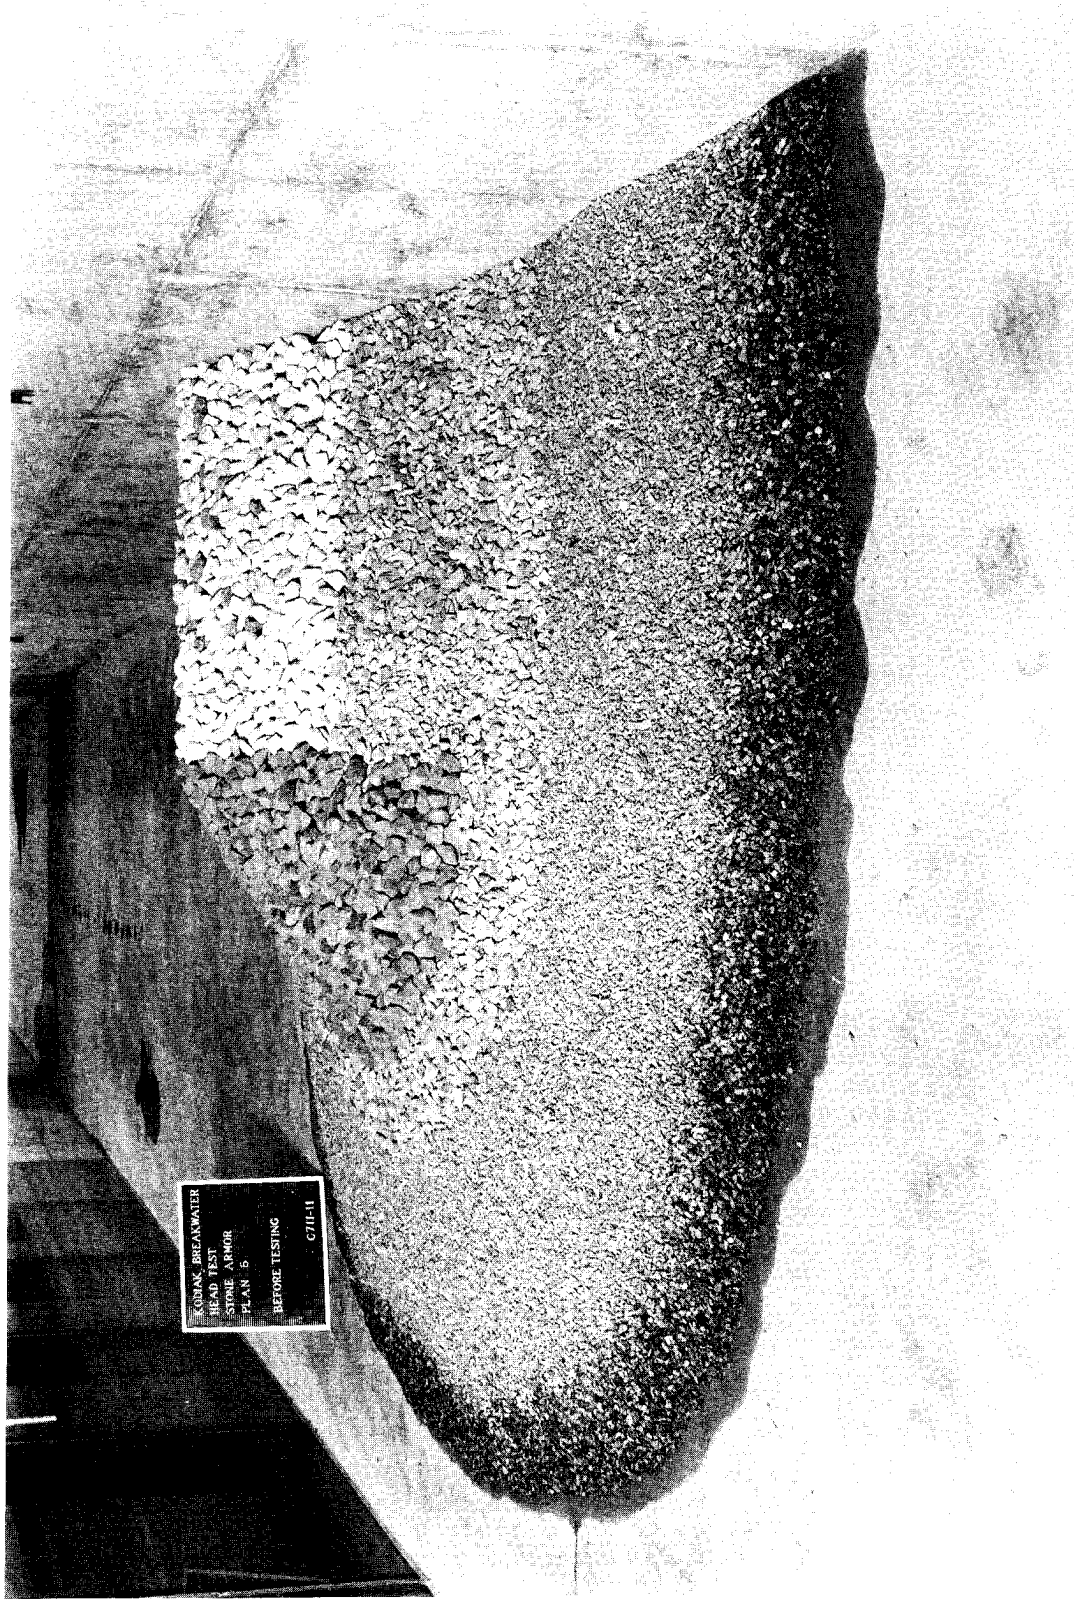
Photo 22. Harbor-side view of model breakwater Plan 5 before testing

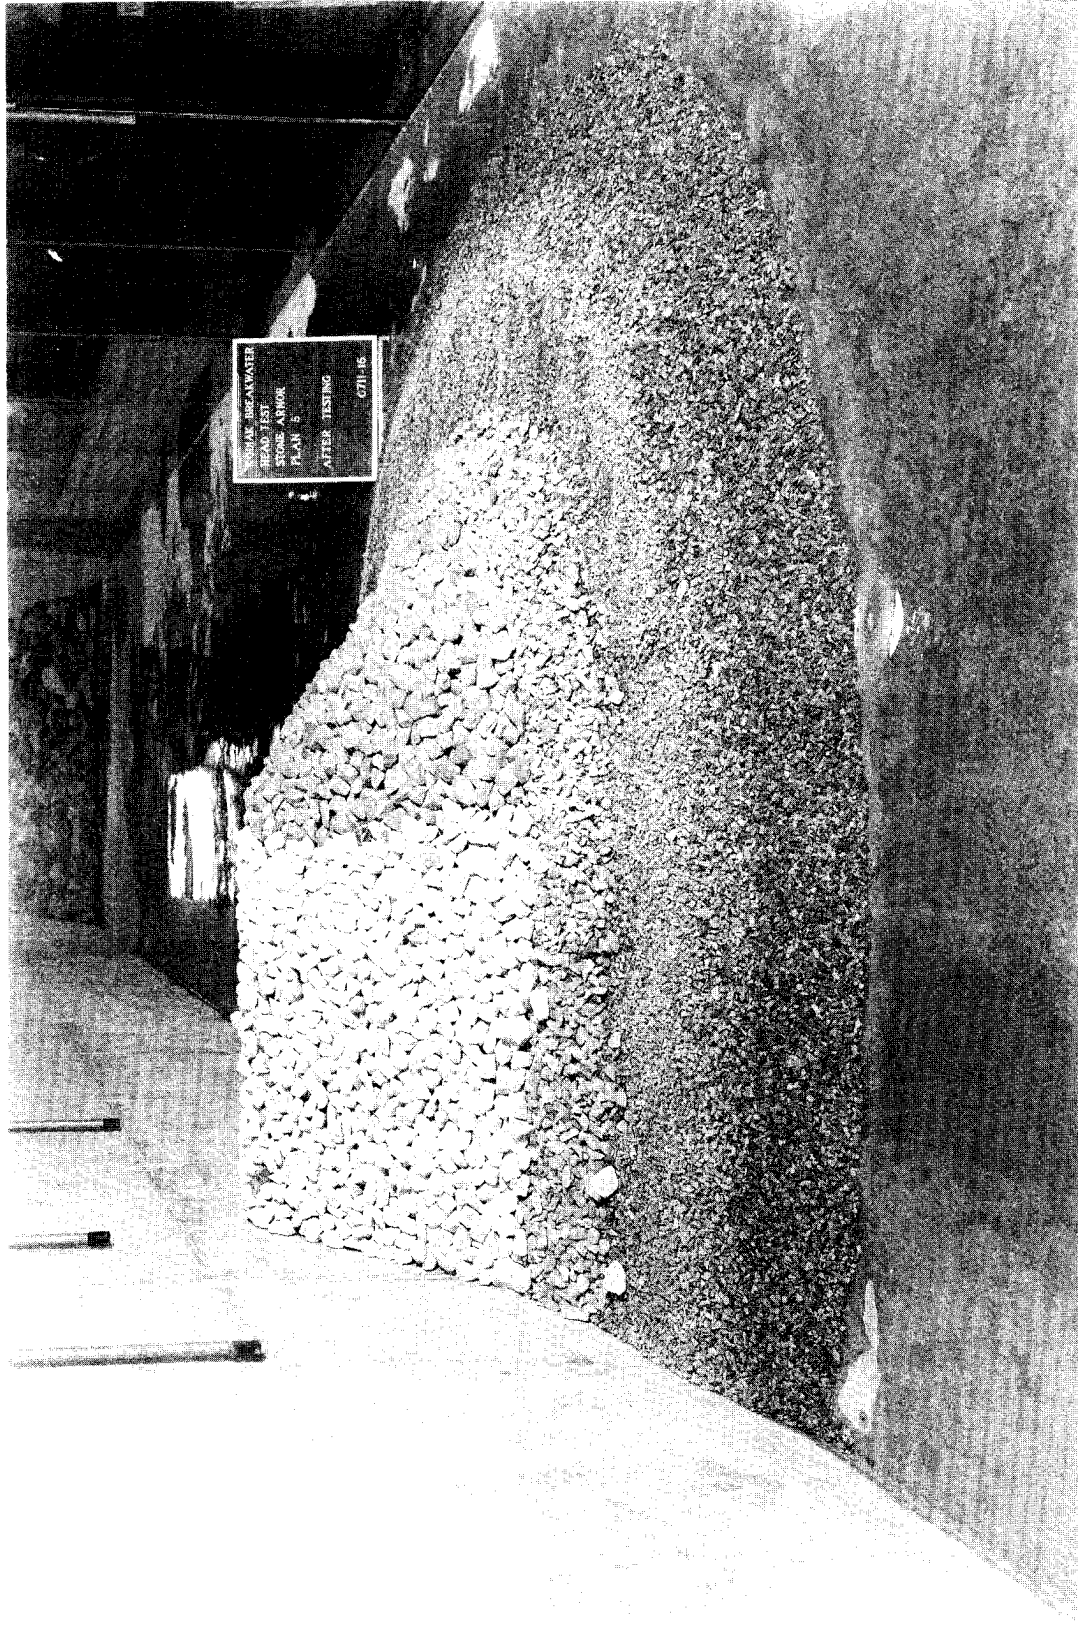
Photo 23. Sea-side view of model breakwater Plan 5 after testing

Water surface elevation next was lowered to 0.0 m (0.0 ft) mllw to test toe stability. Three test runs of 48-min duration each were conducted with $T_p = 14$ sec and $H_{m0} = 1.7$ m (5.5 ft). During the course of the three tests, three stones were dislodged from the slope on the head and one from the sea-side trunk. The structure remained in stable condition. Photos 23, 24, and 25 show the sea side, end view, and harbor side, respectively, of Plan 5 after testing.

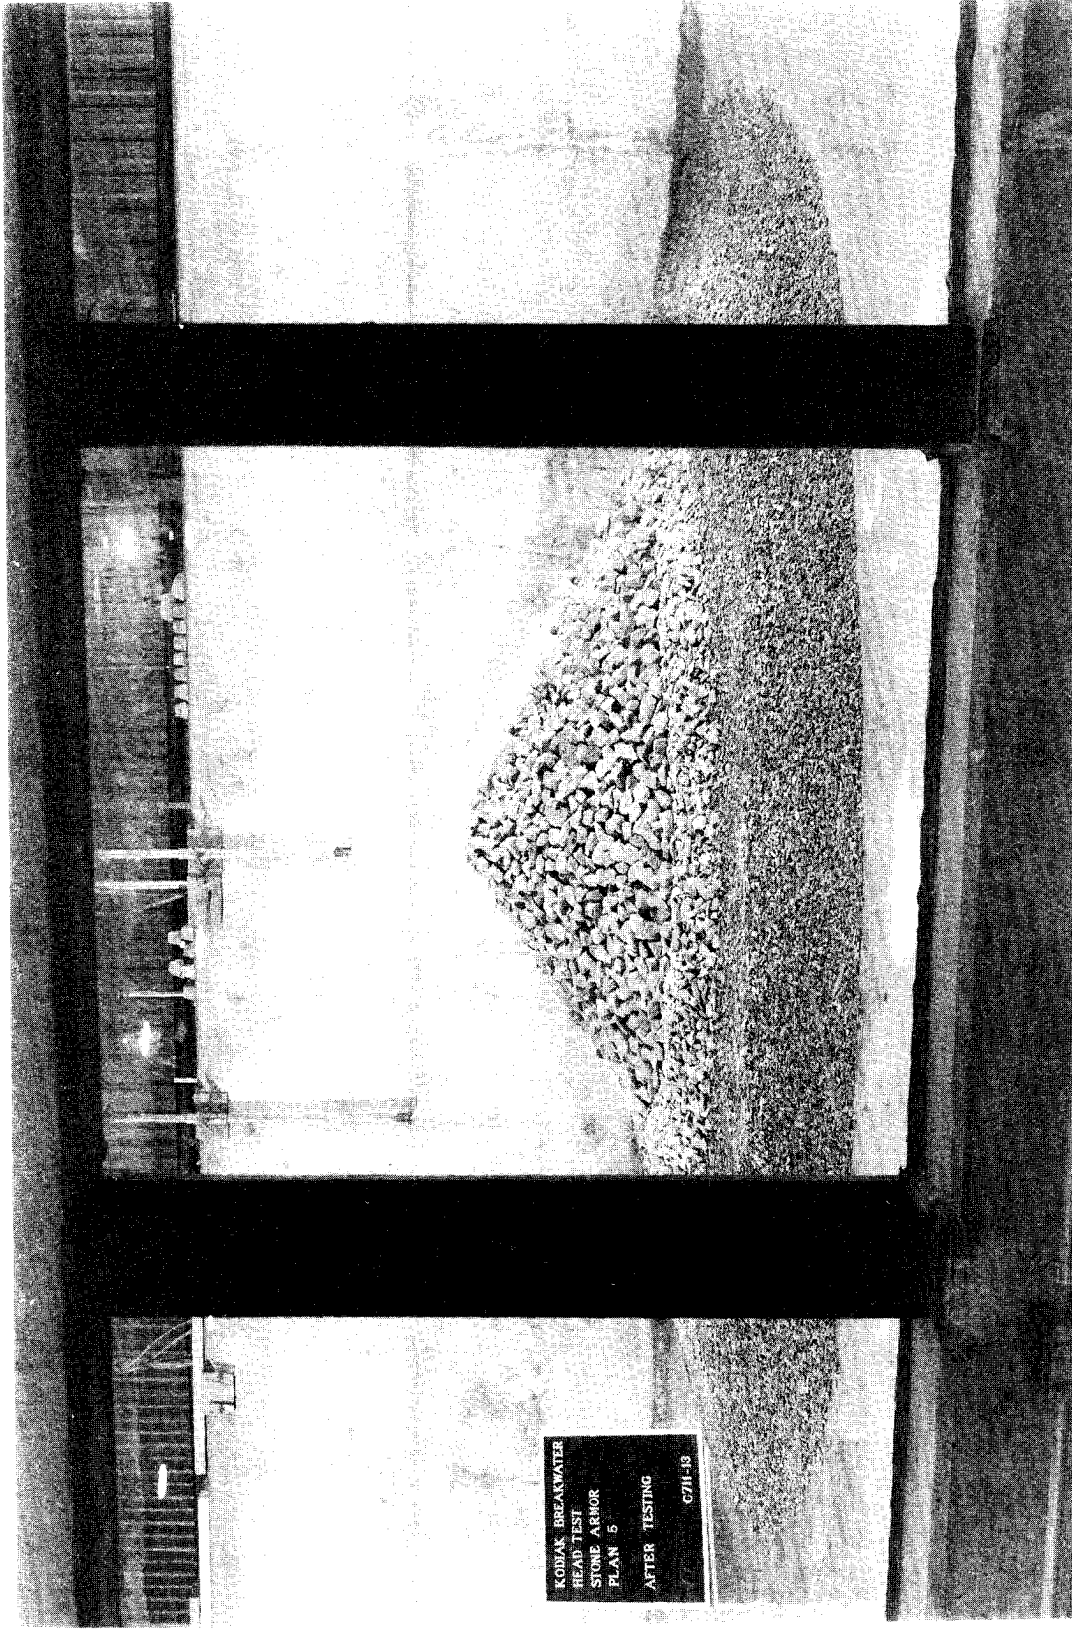
Photo 24. End view of model breakwater Plan 5 after testing

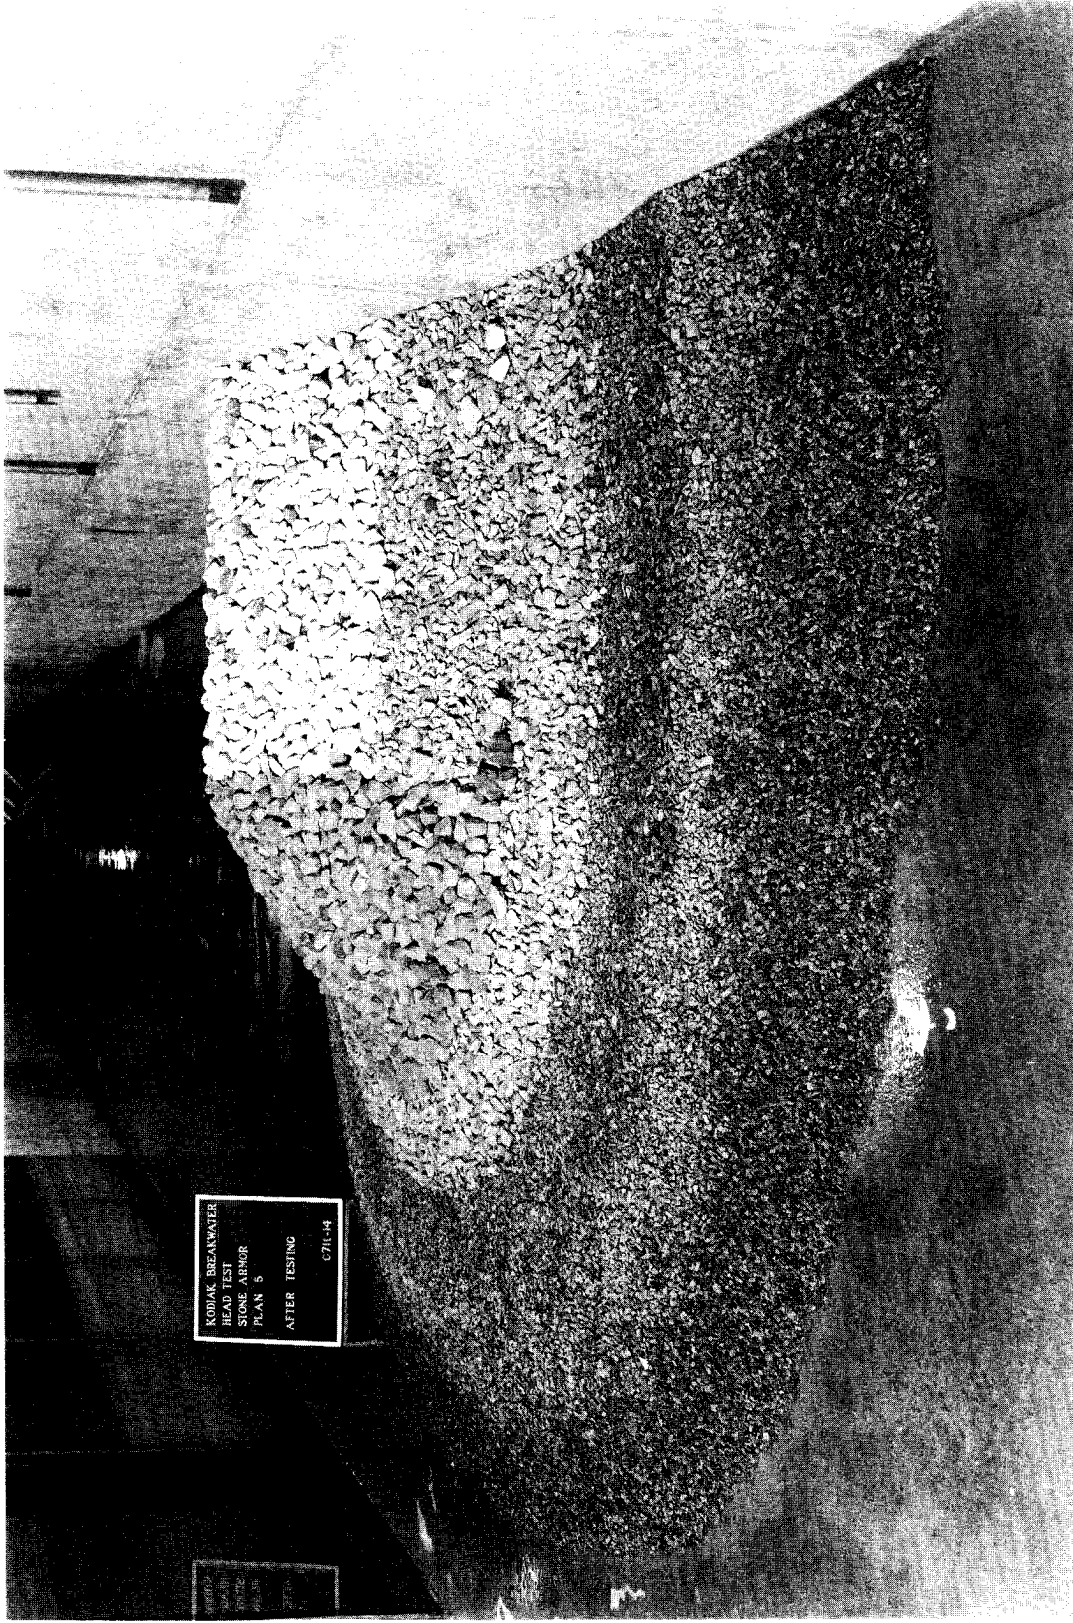
Photo 25. Harbor-side view of model breakwater Plan 5 after testing

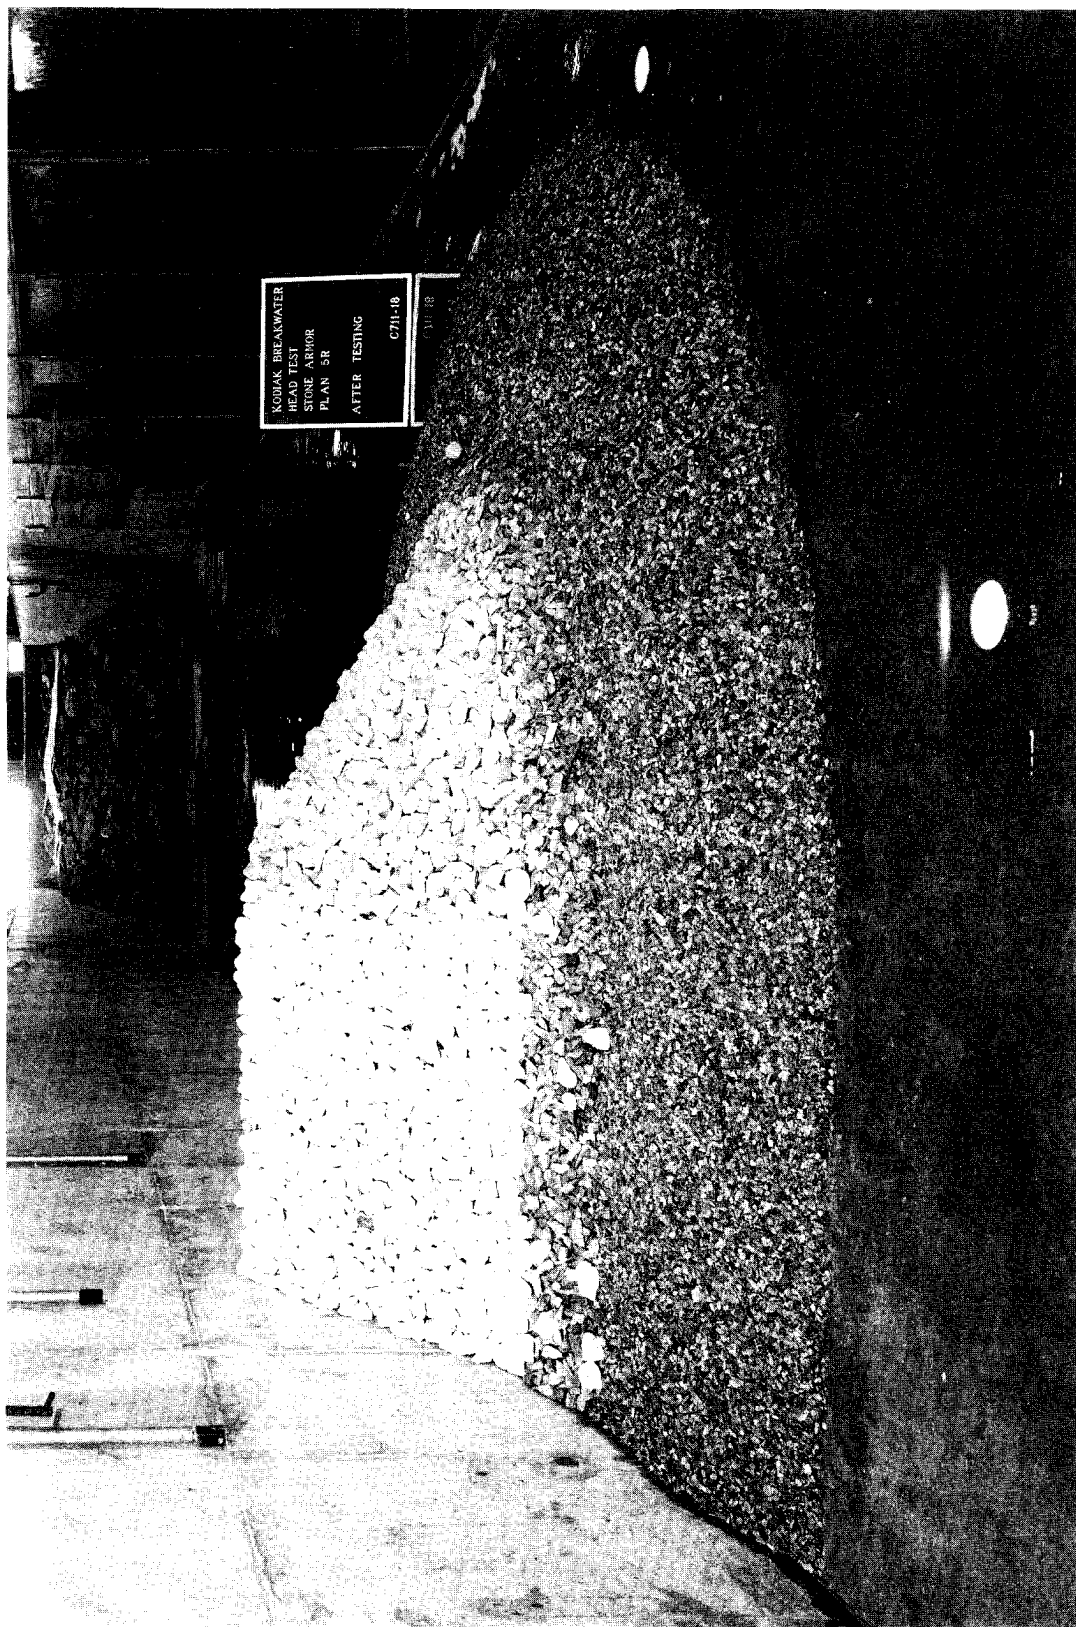
Photo 26. Sea-side view of model breakwater Plan 5R after testing

The final three test runs of the St. Herman Harbor stability test series were conducted at swl = 0.0 m (0.0 ft) mllw with $T_p = 14$ sec and $H_{m0} = 1.7$ m (5.5 ft). Each of the last three runs was of 48-min duration. Three additional stones were lost from the scour hole on the sea-side trunk with minor additional damage observed elsewhere on the structure. No damage was detected on the structure toe or consolidation pad. Photos 26, 27, and 28 show the sea side, end view, and harbor side, respectively, of Plan 5R after testing.
